# Tree damage in the vicinity of mobile phone base stations

Cornelia Waldmann-Selsam and Horst Eger

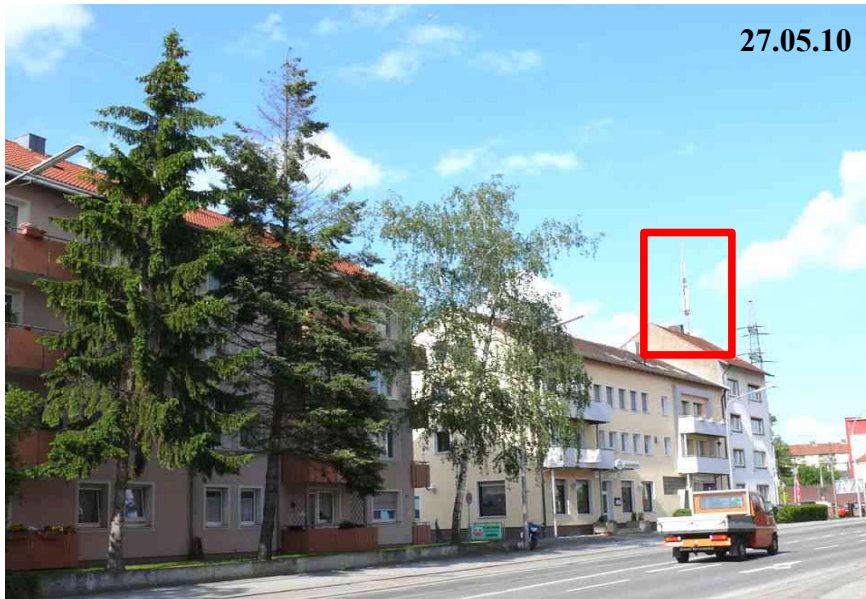
Fig. 3a: 27 May 2010: Two spruce trees and a birch tree in the radiation field of the mobile phone base station Zollnerstraße in Bamberg in May 2010. The spruce tree facing the transmitter has lost many needles in the upper part. The birch tree does not grow upwards (Photo: C. Waldmann-Selsam).

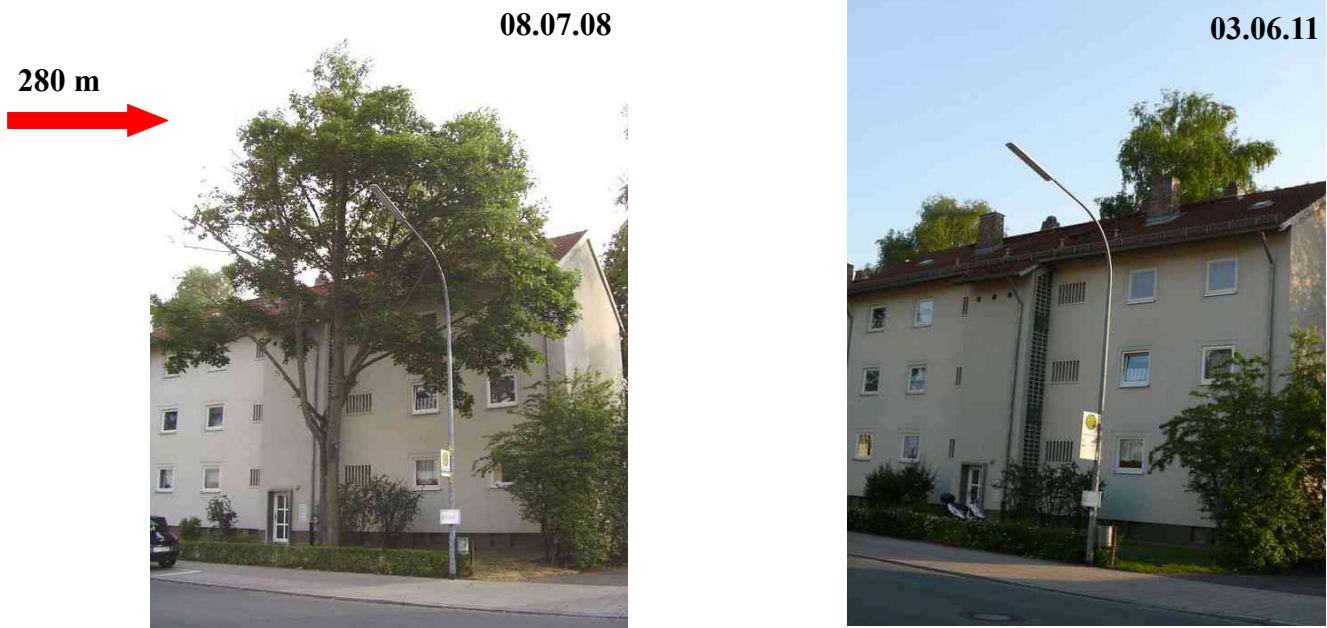
Fig. 4a: 8 July 2008: Unilaterally damaged and already trimmed maple tree with line of sight to the base station Hauptsmoorstr. 26 a in Bamberg (Photo: C. Waldmann-Selsam).

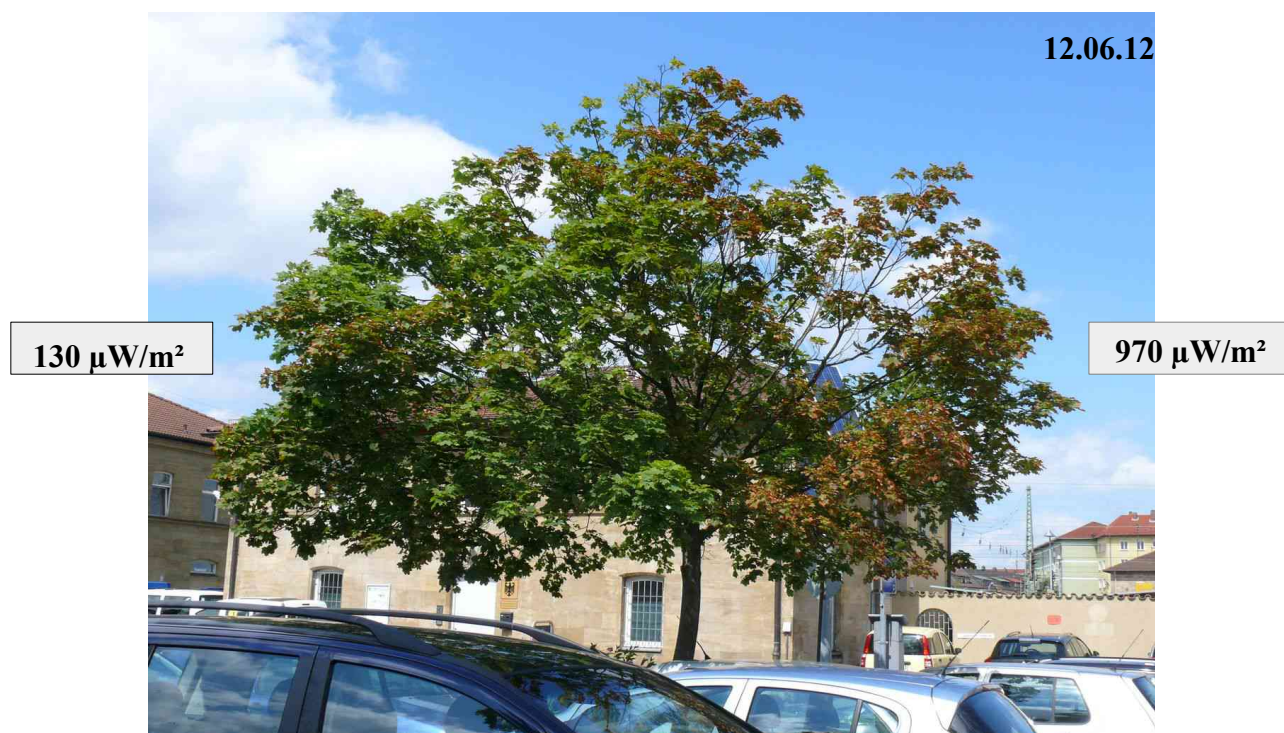
Fig. 5: 26 June 2012: One-sided damaged maple tree on a grass verge at the parking lot of the railway station in Bamberg. There is line of sight to mobile phone base stations. The measurements in a height of 3 meters showed considerable differences between the south and the northeast side: south side:  $970 \mu\text{W}/\text{m}^2$ , northeast side  $130 \mu\text{W}/\text{m}^2$  (Photo: C. Waldmann-Selsam).
